# **BS7976 -2 Pendulum Slip Test**

**Customer: FibreGrid**

**Test Number: FS10185**

**Surface:Rungrip 25**

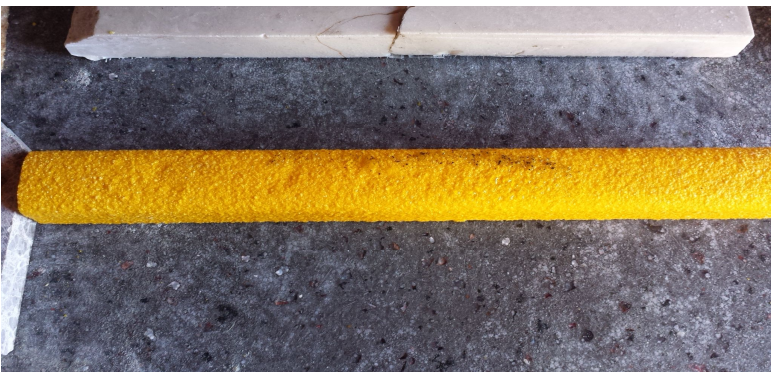
Dry Principal	62	59	59	59	59	59	59	59	59	Low
Dry 45 degree										
Dry 90 degree

Wet principal	57	56	55	55	55	55	55	55	55	Low
Wet 45 degrees										
Wet 90 Degrees

If a sample has been sent for lab testing we highly recommend a re-test in situ.
